Manhole Inspection Summary

Manhole # S47K__019MH

Insp Date: **2/10/09 3:03 PM**

Location Address: **2030 ALICEANNA ST**

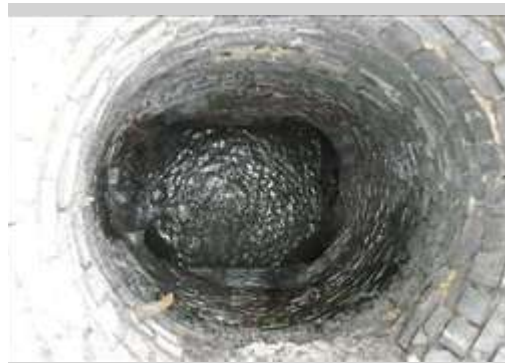
Top View

Comments **ARRIVED AND FOUND COVER STUCK AND BROKEN INSIDE RID. USED 16LB MAUL TO BREAK AND REMOVE LID. HEAVY ACTIVE FRESHWATER INFILTRATION - SMELLS LIKE HARBOR WATER - THROUGH CORBEL AND BARREL WALLS. HEAVY FLOW IN PIPE PREVENTED GETTING ACCURATE INVERT DEPTHS**
